# 12 August 2014 Needles, CA

## Microburst and Flash Flooding

Justin Pullin

National Weather Service Las Vegas, NV

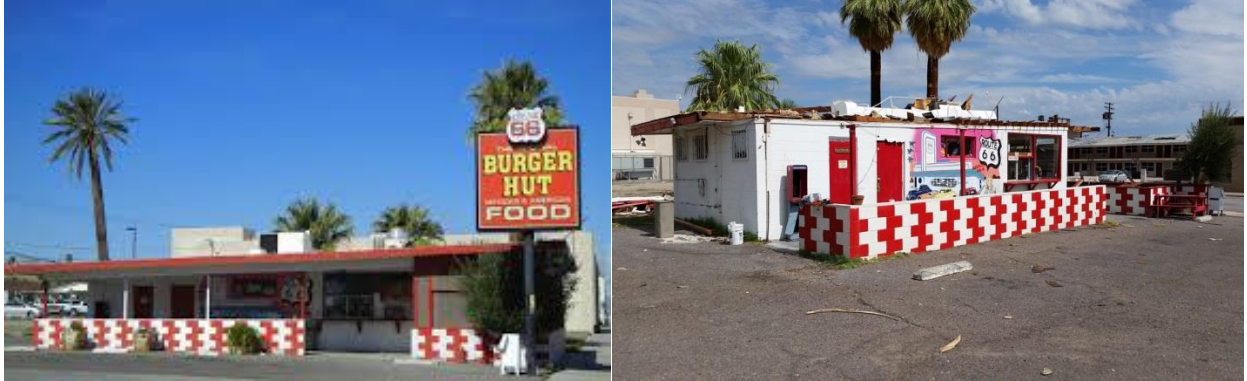
The bulk of the heavy damage from the downburst was located on the northeast side of I-40, in the Broadway Street/Route 66 area. While winds reached severe levels (>58 mph), the severity of damage was exacerbated by the building structures and age. For example, the 57 year-old Burger Hut building had a porch on its western facing side, making the roof susceptible to strong surface winds from this direction. The damage survey showed the roof was “peeled” back from the porch area. The same was the case at Lucy’s Mexican restaurant with an awning over the entrance and an apartment building’s second floor walkway (see Picture 2 and 3). The trees that were blown over throughout the town exhibited shallow root systems, which are common in the Desert Southwest, making them prone to high winds. Outside of downtown Needles, much of the damage noted was missing shingles from homes, downed power lines, and flash flooding damage in and around washes.

**Picture 1.** A before and after photo of the Burger Hut in downtown Needles, CA. The before picture is courtesy of Google Images, and the after photo was taken on the damage survey by Dan Berc of NWS Las Vegas.

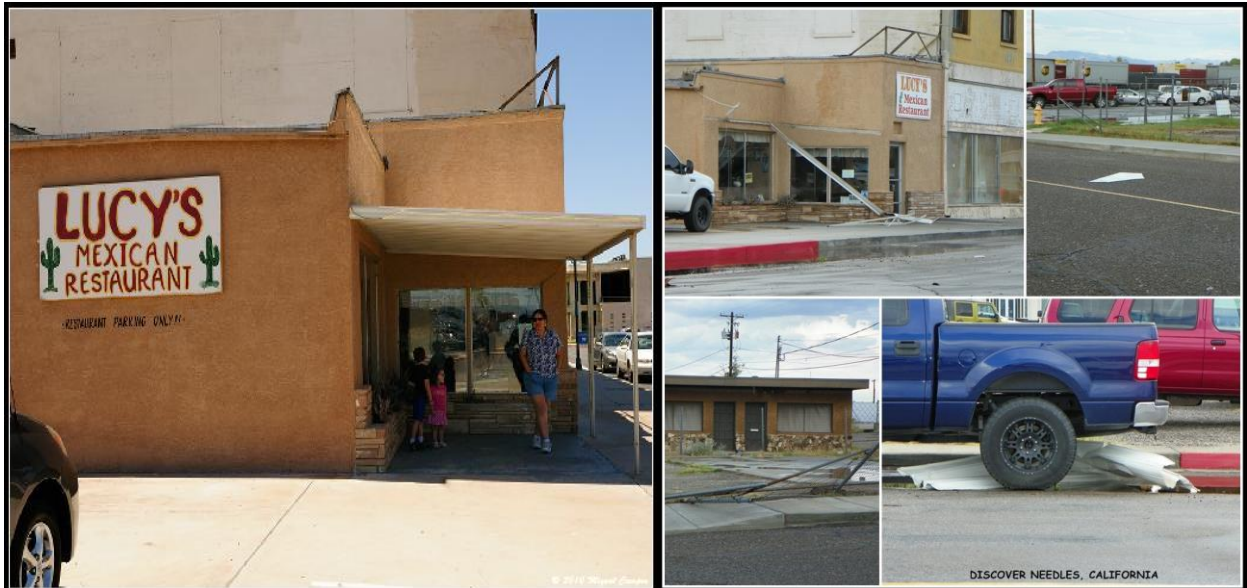
**Picture 2.** A before and after shot Lucy's Mexican Restaurant in downtown Needles, CA. The before photo is courtesy of Google Images, and the after photo is courtesy of Discover Needles, California Facebook page.

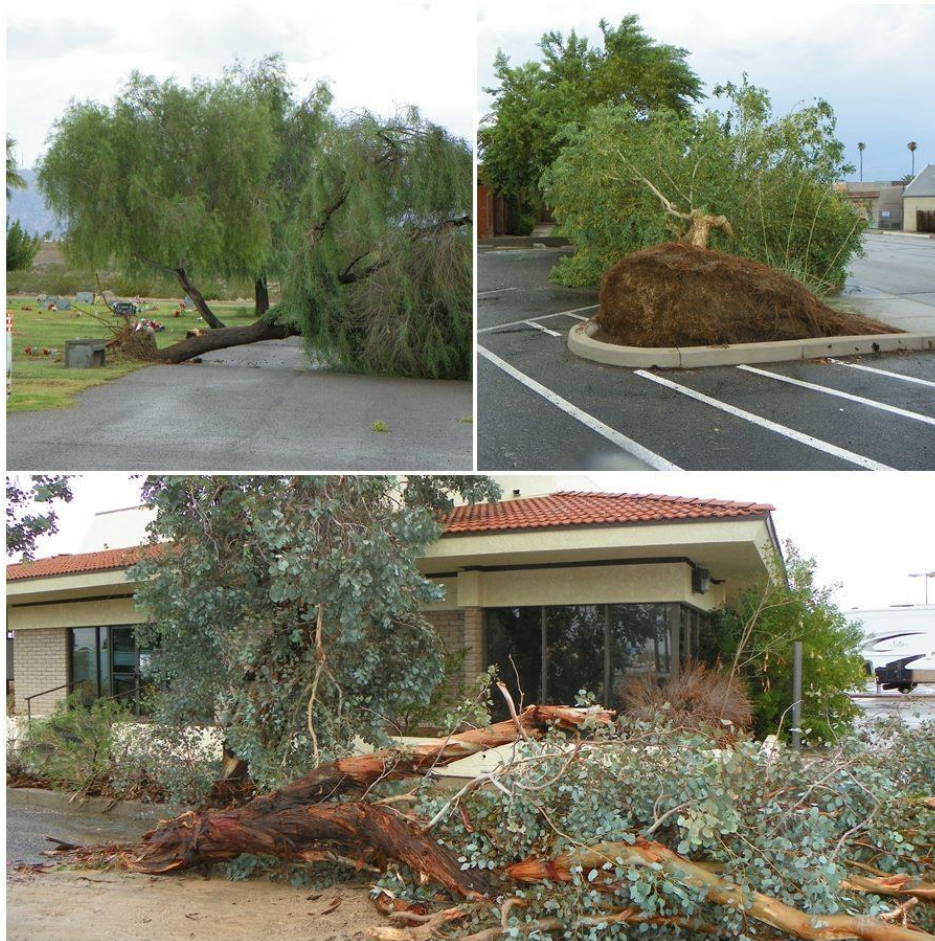
**Picture 3.** Picture collage of downed trees around Needles. Note the shallow root systems, which are common in the Desert Southwest. This makes trees more susceptible to high winds. The photo collage is courtesy of Discover Needles, California Facebook page.

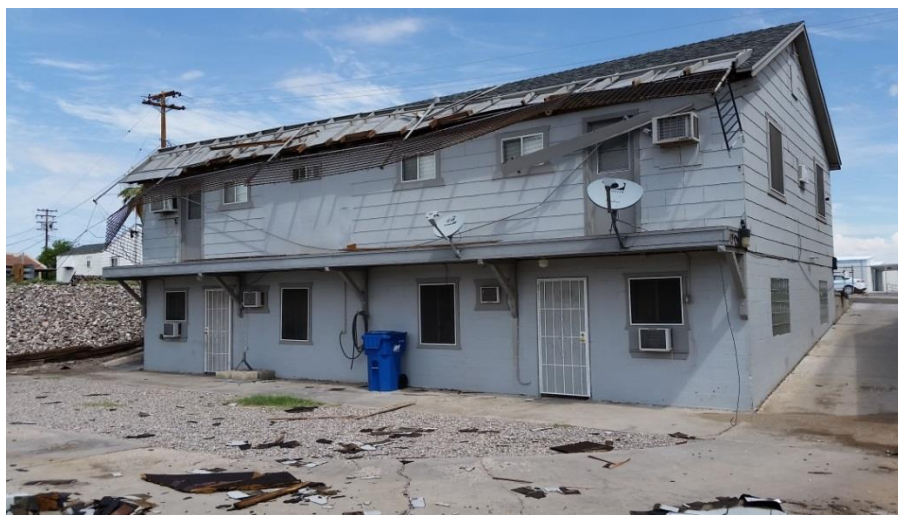
**Picture 4.** Picture of an apartment balcony flipped over on its roof. The photo was taken on the damage survey by Dan Berc of NWS Las Vegas.

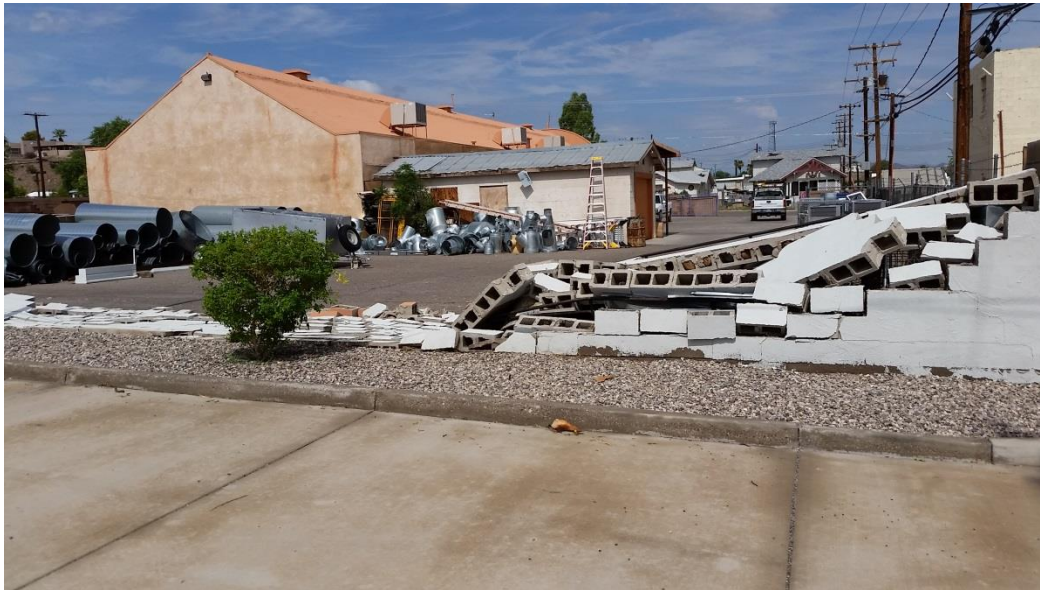
**Picture 5.** Picture of a cinder block wall blown down by the wind in Downtown Needles. The photo was taken on the damage survey by Dan Berc of NWS Las Vegas.

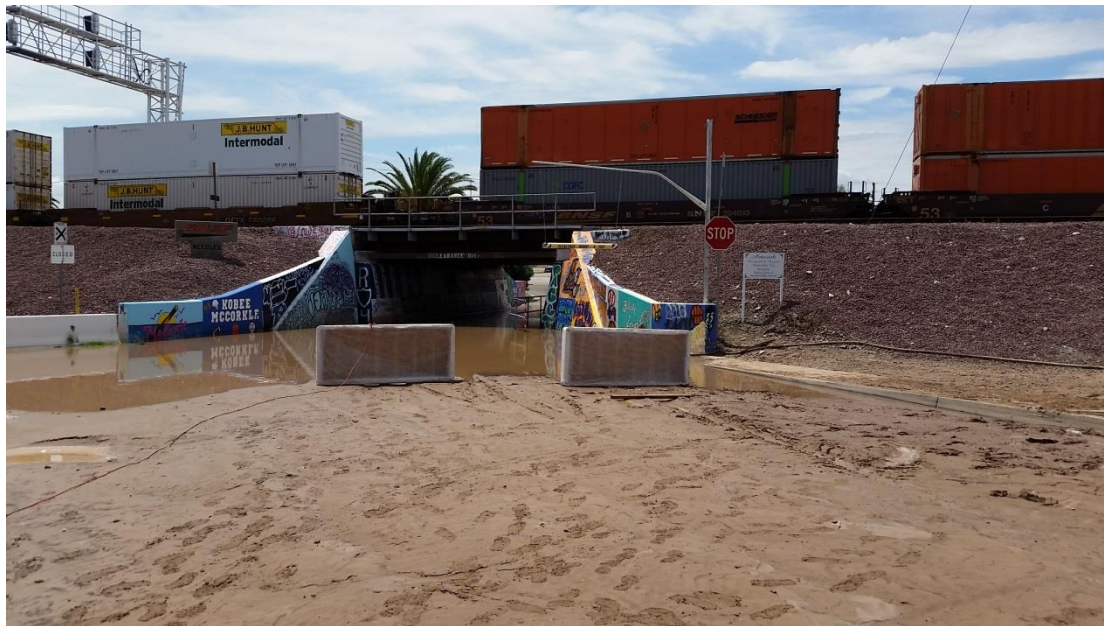
**Picture 6.** Picture of the aftermath of flash flooding in a wash beneath BNSF railroad track in Needles, CA. The photo was taken on the damage survey by Dan Berc of NWS Las Vegas.
